## PHOTOGRAPHIC LOG

**SIA**

**Limited Assessment**  
6222 E. Desmet Avenue  
Spokane, Washington

**SES Project No.: 0270-003**  
**Date:** March 2019

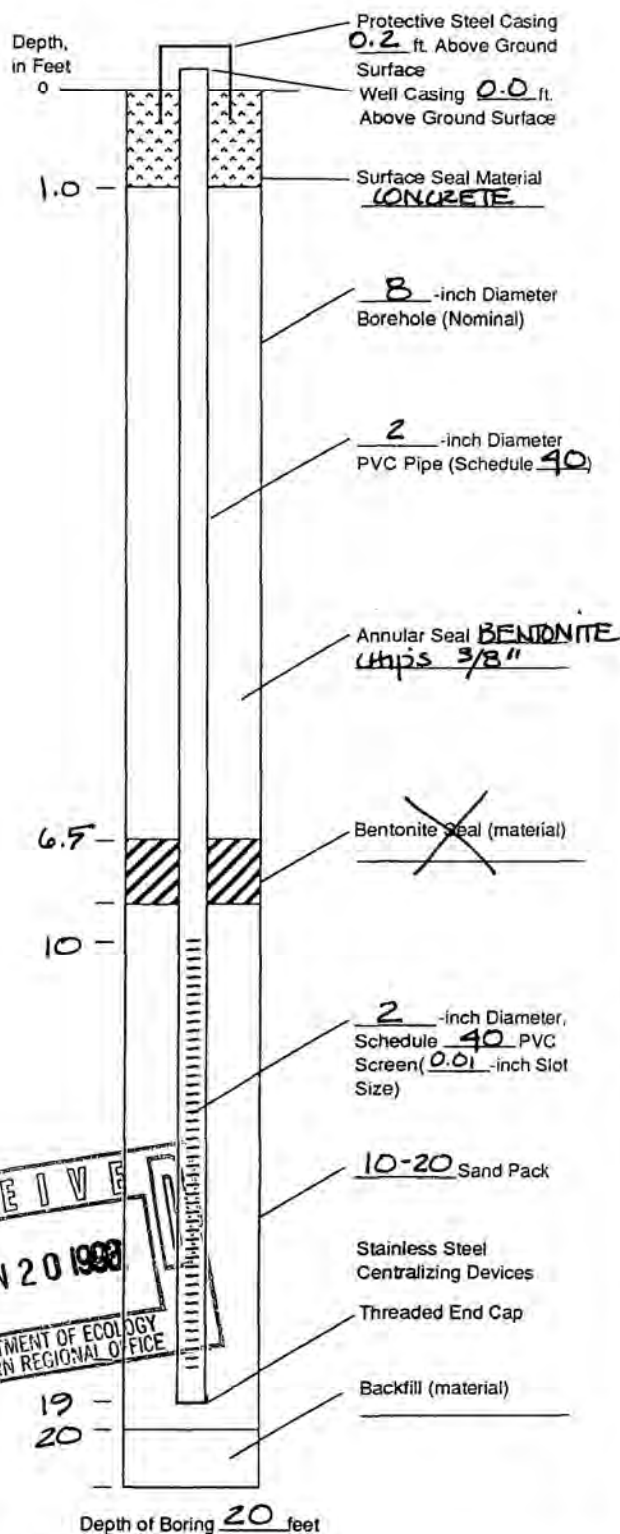
AS-BUILT	WELL DATA	FORMATION DESCRIPTION
<p>See attached sheet</p>	GM	DARK brown silty to sandy GRAVEL (med. dense, moist) 5.0
	SW	Dark brown Gravelly medium to very coarse SAND (loose, moist) 10.0
	GM	Dark brown silty sandy GRAVEL (loose, moist) 15.0
	ML	Medium brown fine sandy SILT w/ trace charcoal and leaves (very stiff damp) 20.0
		END OF HOLE 20 FT.
<p><i>Will Hayes</i>                      RUEN DRILLING, INC.                      BOX 267                      CLARK FORK, ID 83811                      (208) 266-1151</p>		29.0
		30.0
		35.0

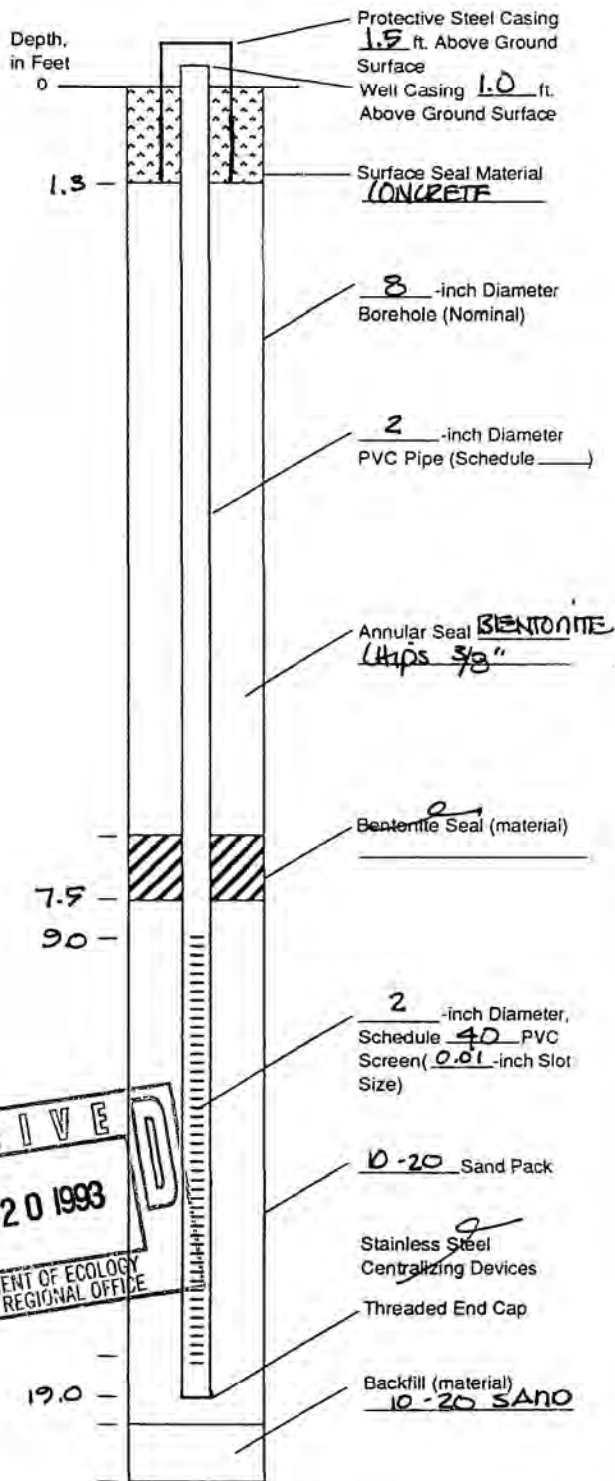
MATERIALS USED	
<u>15</u>	Sacks of <u>10-20</u> Sand
<u>2</u>	Sacks of Concrete/Cement
	Sacks of Grout Mix Used
<u>3</u>	Sacks of Powdered Bentonite <u>Chips</u>
	Pounds of Bentonite Pellets/Chips
<u>10</u>	Feet of <u>2</u> Inch PVC Blank Casing
<u>10</u>	Feet of <u>2</u> Inch PVC Slotted Screen

Depth of Boring 20.5 feet

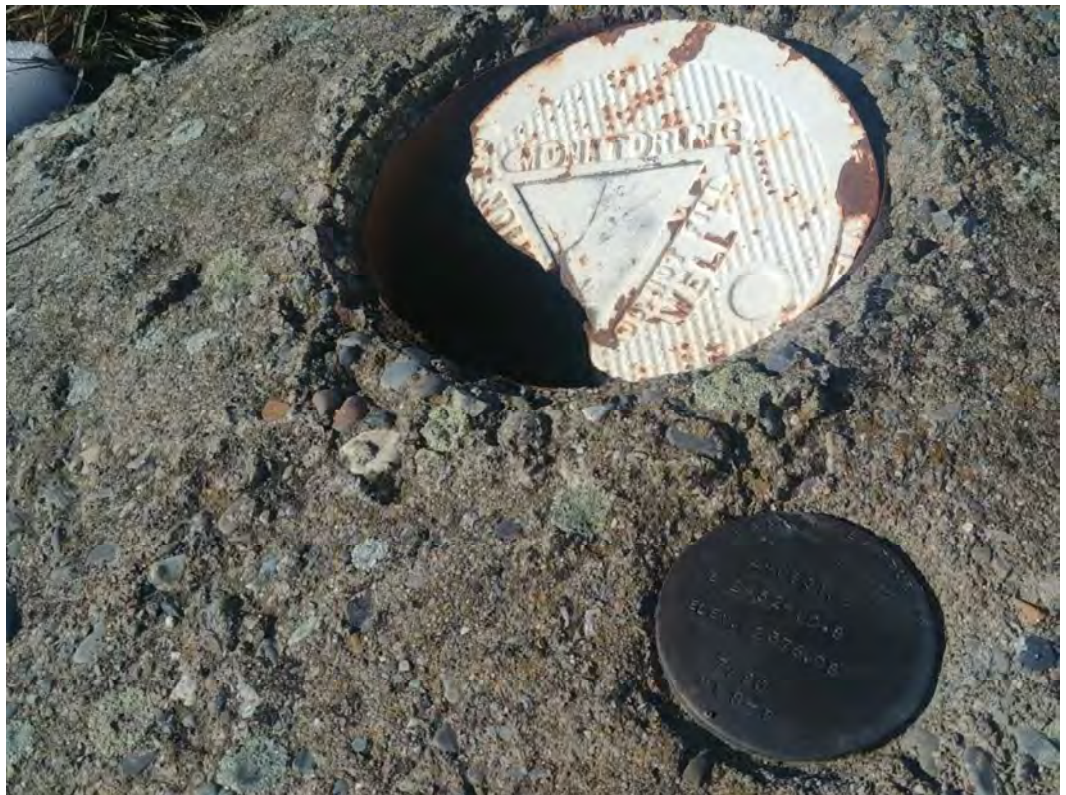
**Photo No.**  
**2**

View of the broken monument lid on MW-8b. The entire monument should be replaced.

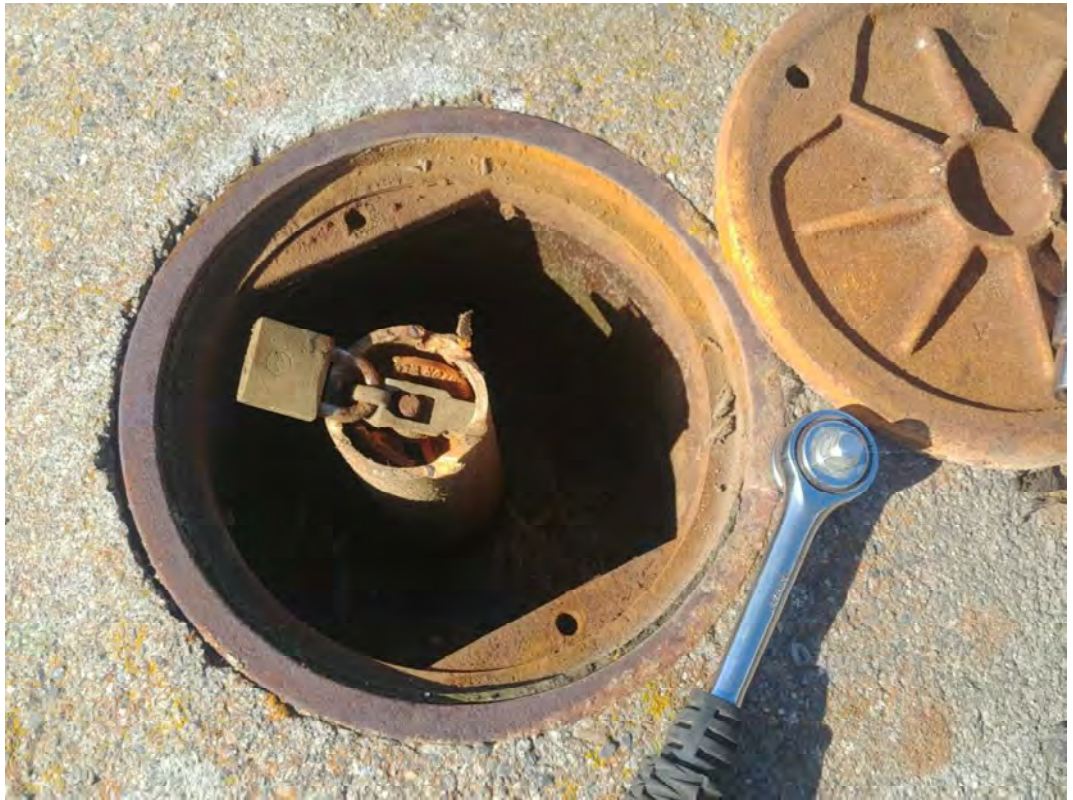
**Photo No.**  
**3**

View of MW-14. The soil supporting the monument has compacted and/or there is evidence of burrowing which has further removed support. The concrete monuments are supported by the well casings. This will eventually cause the casings to break. The monuments

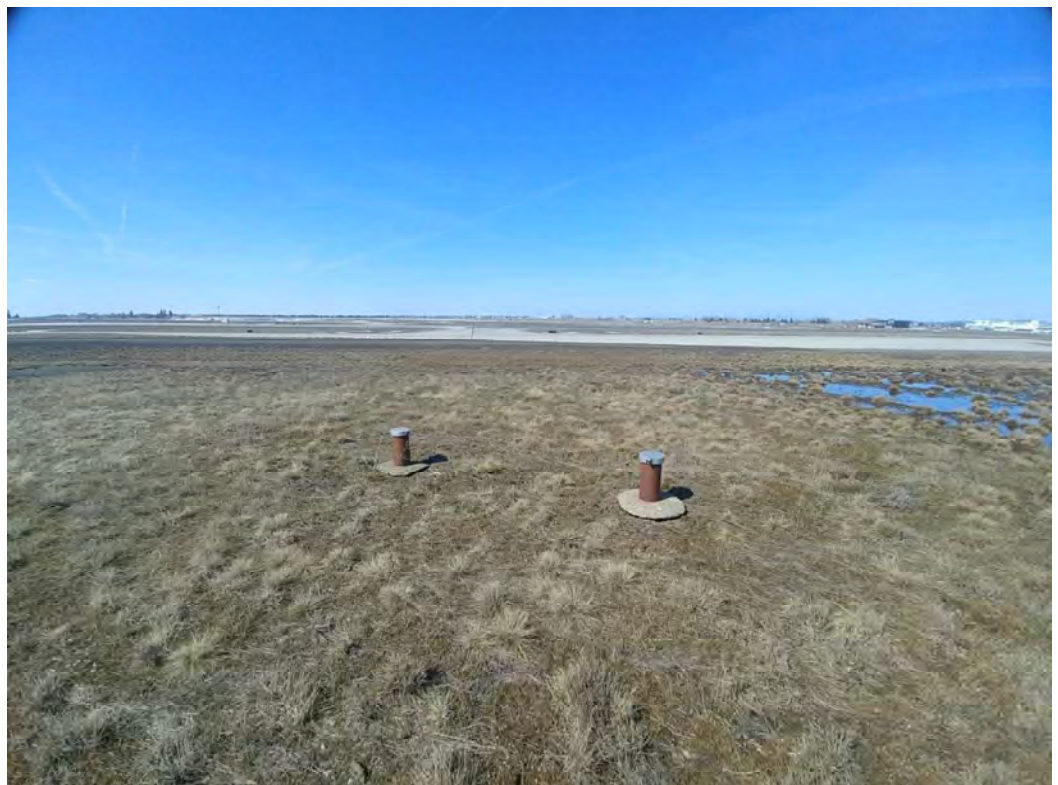
**Photo No.**  
**4**

View of the MW-14 well pair. SES replaced the locks on the well caps.
