SURFACE WATER FEATURES
OF THE SITE

Site Assessment Report
Spokane International Airport
Spokane, Washington

Locations of Potential or Known Usage of Firefighting Foam

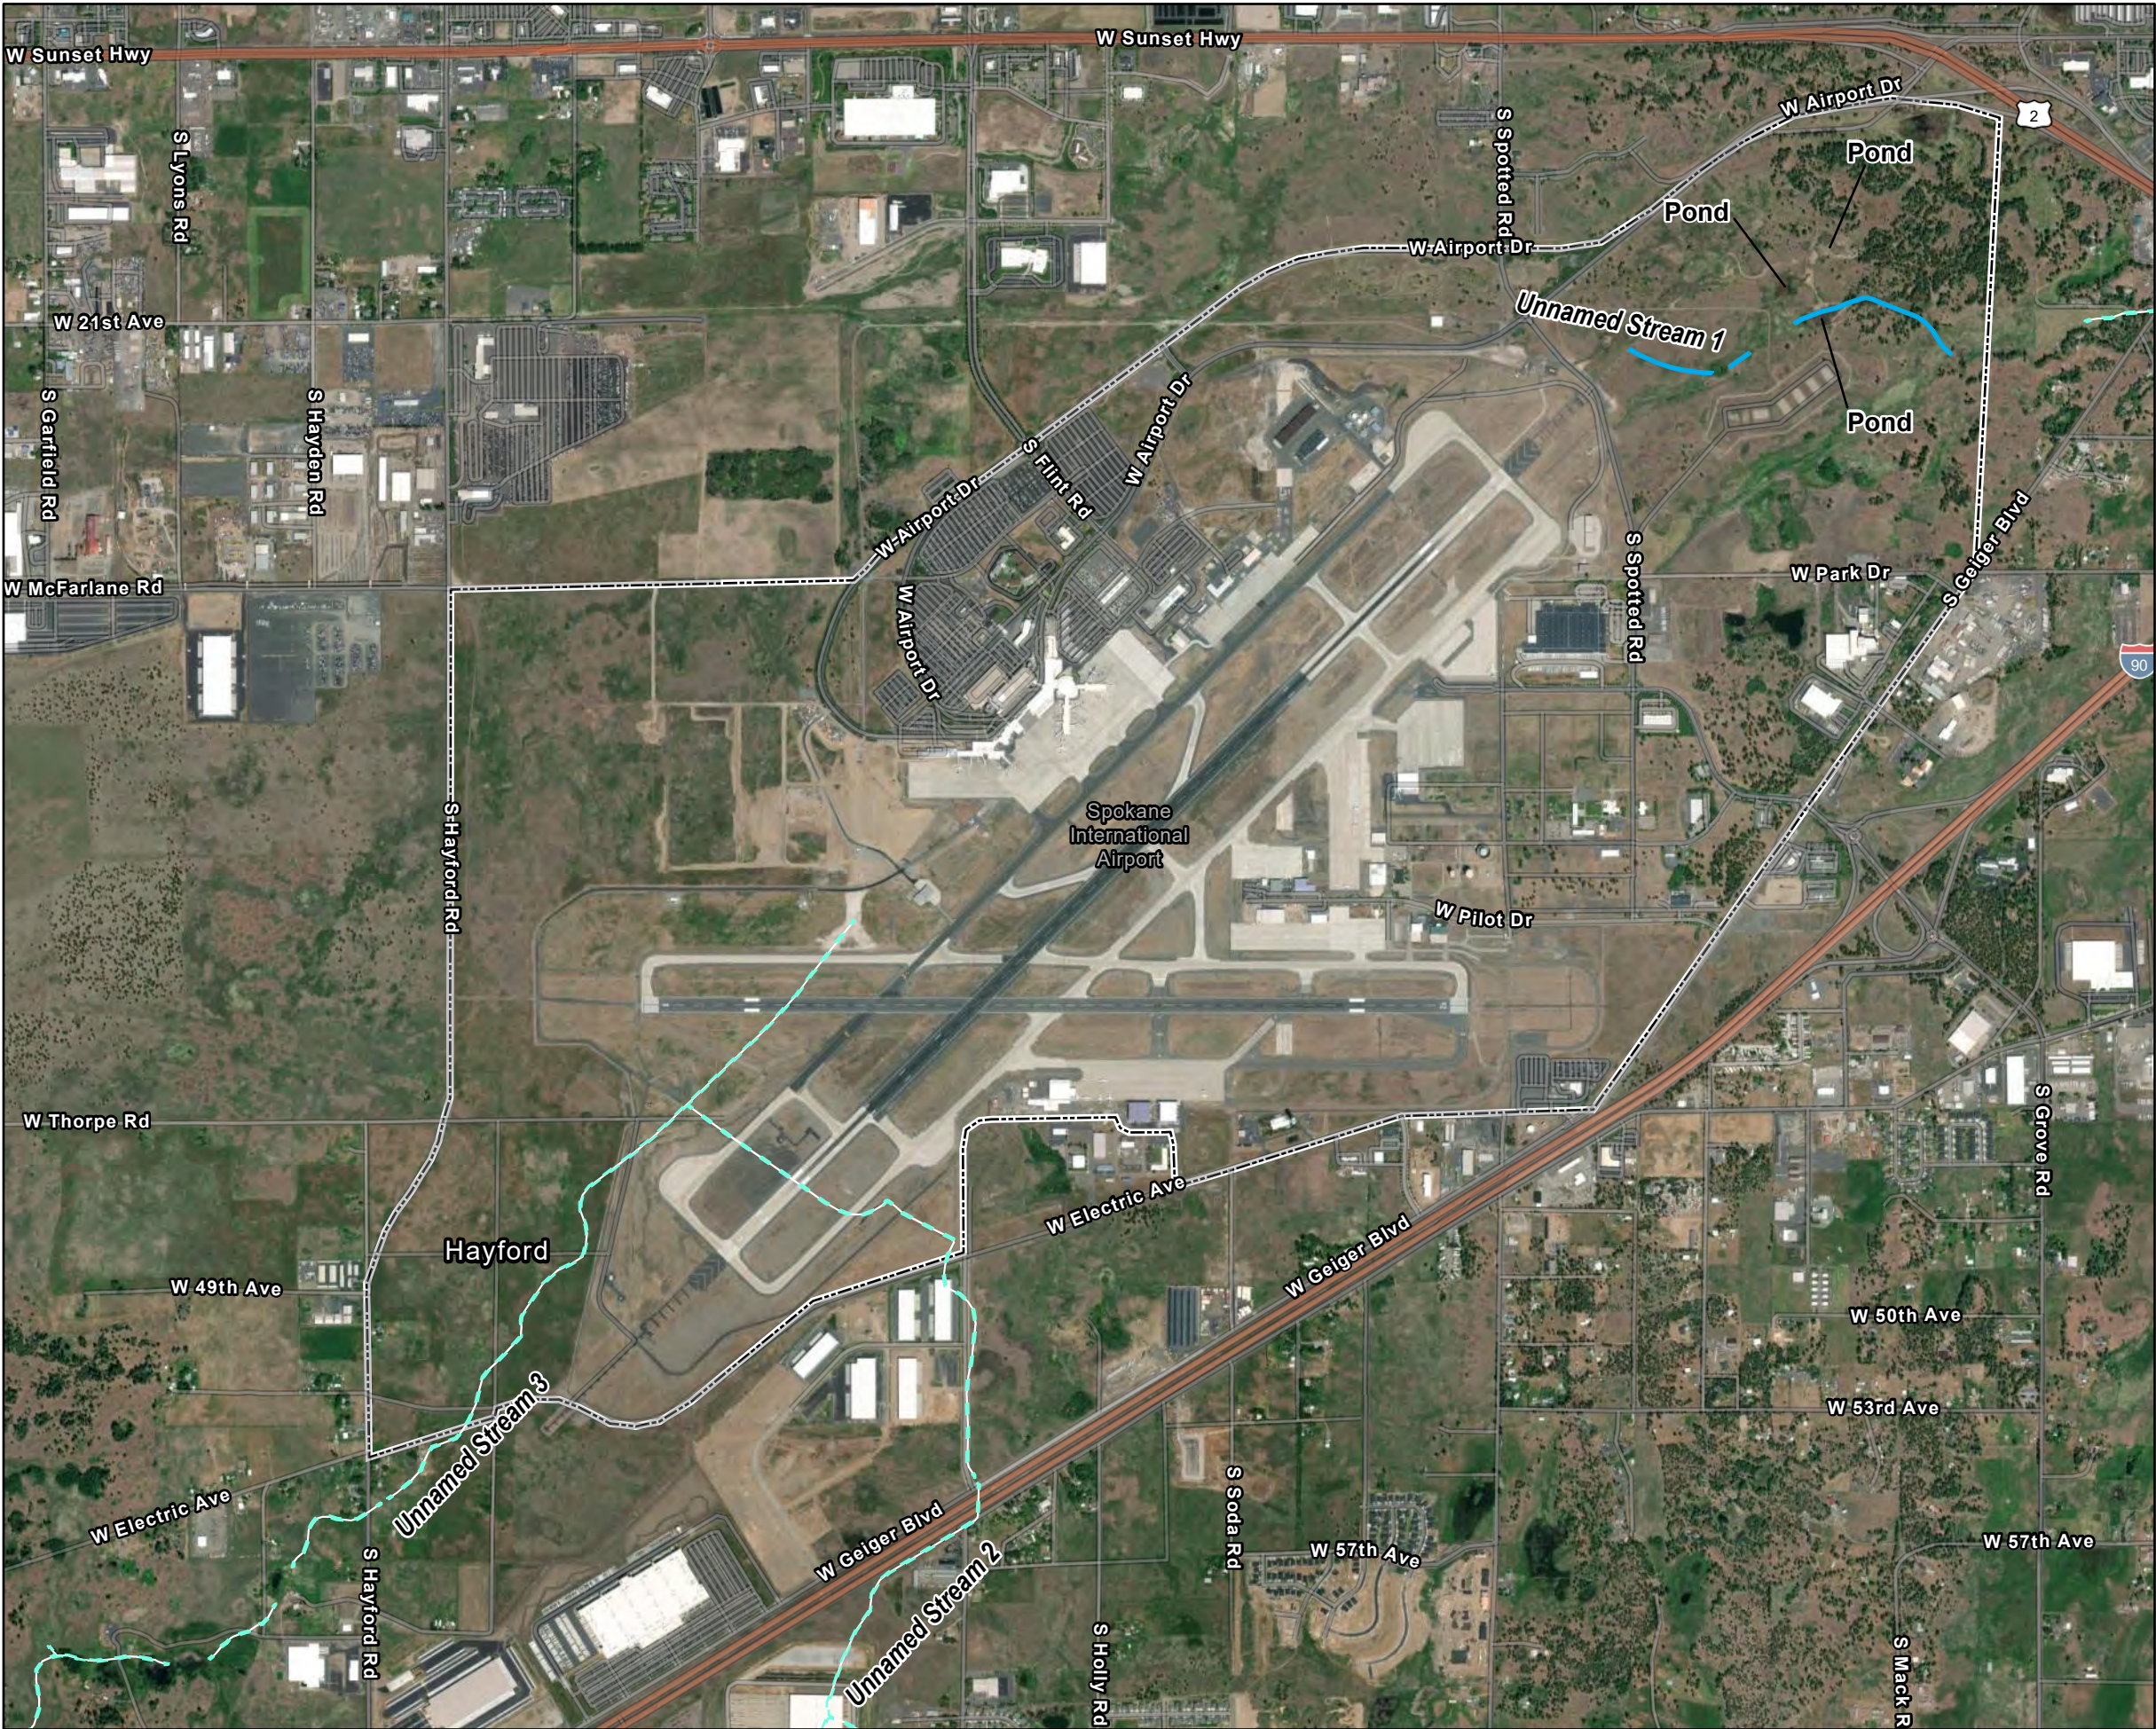
FIGURE 2.4

- 1.) AOA - Air Operations Area
- 2.) All ponds are ephemeral.
- 3.) Aerial imagery provided by Esri ArcGIS Online, 2023.

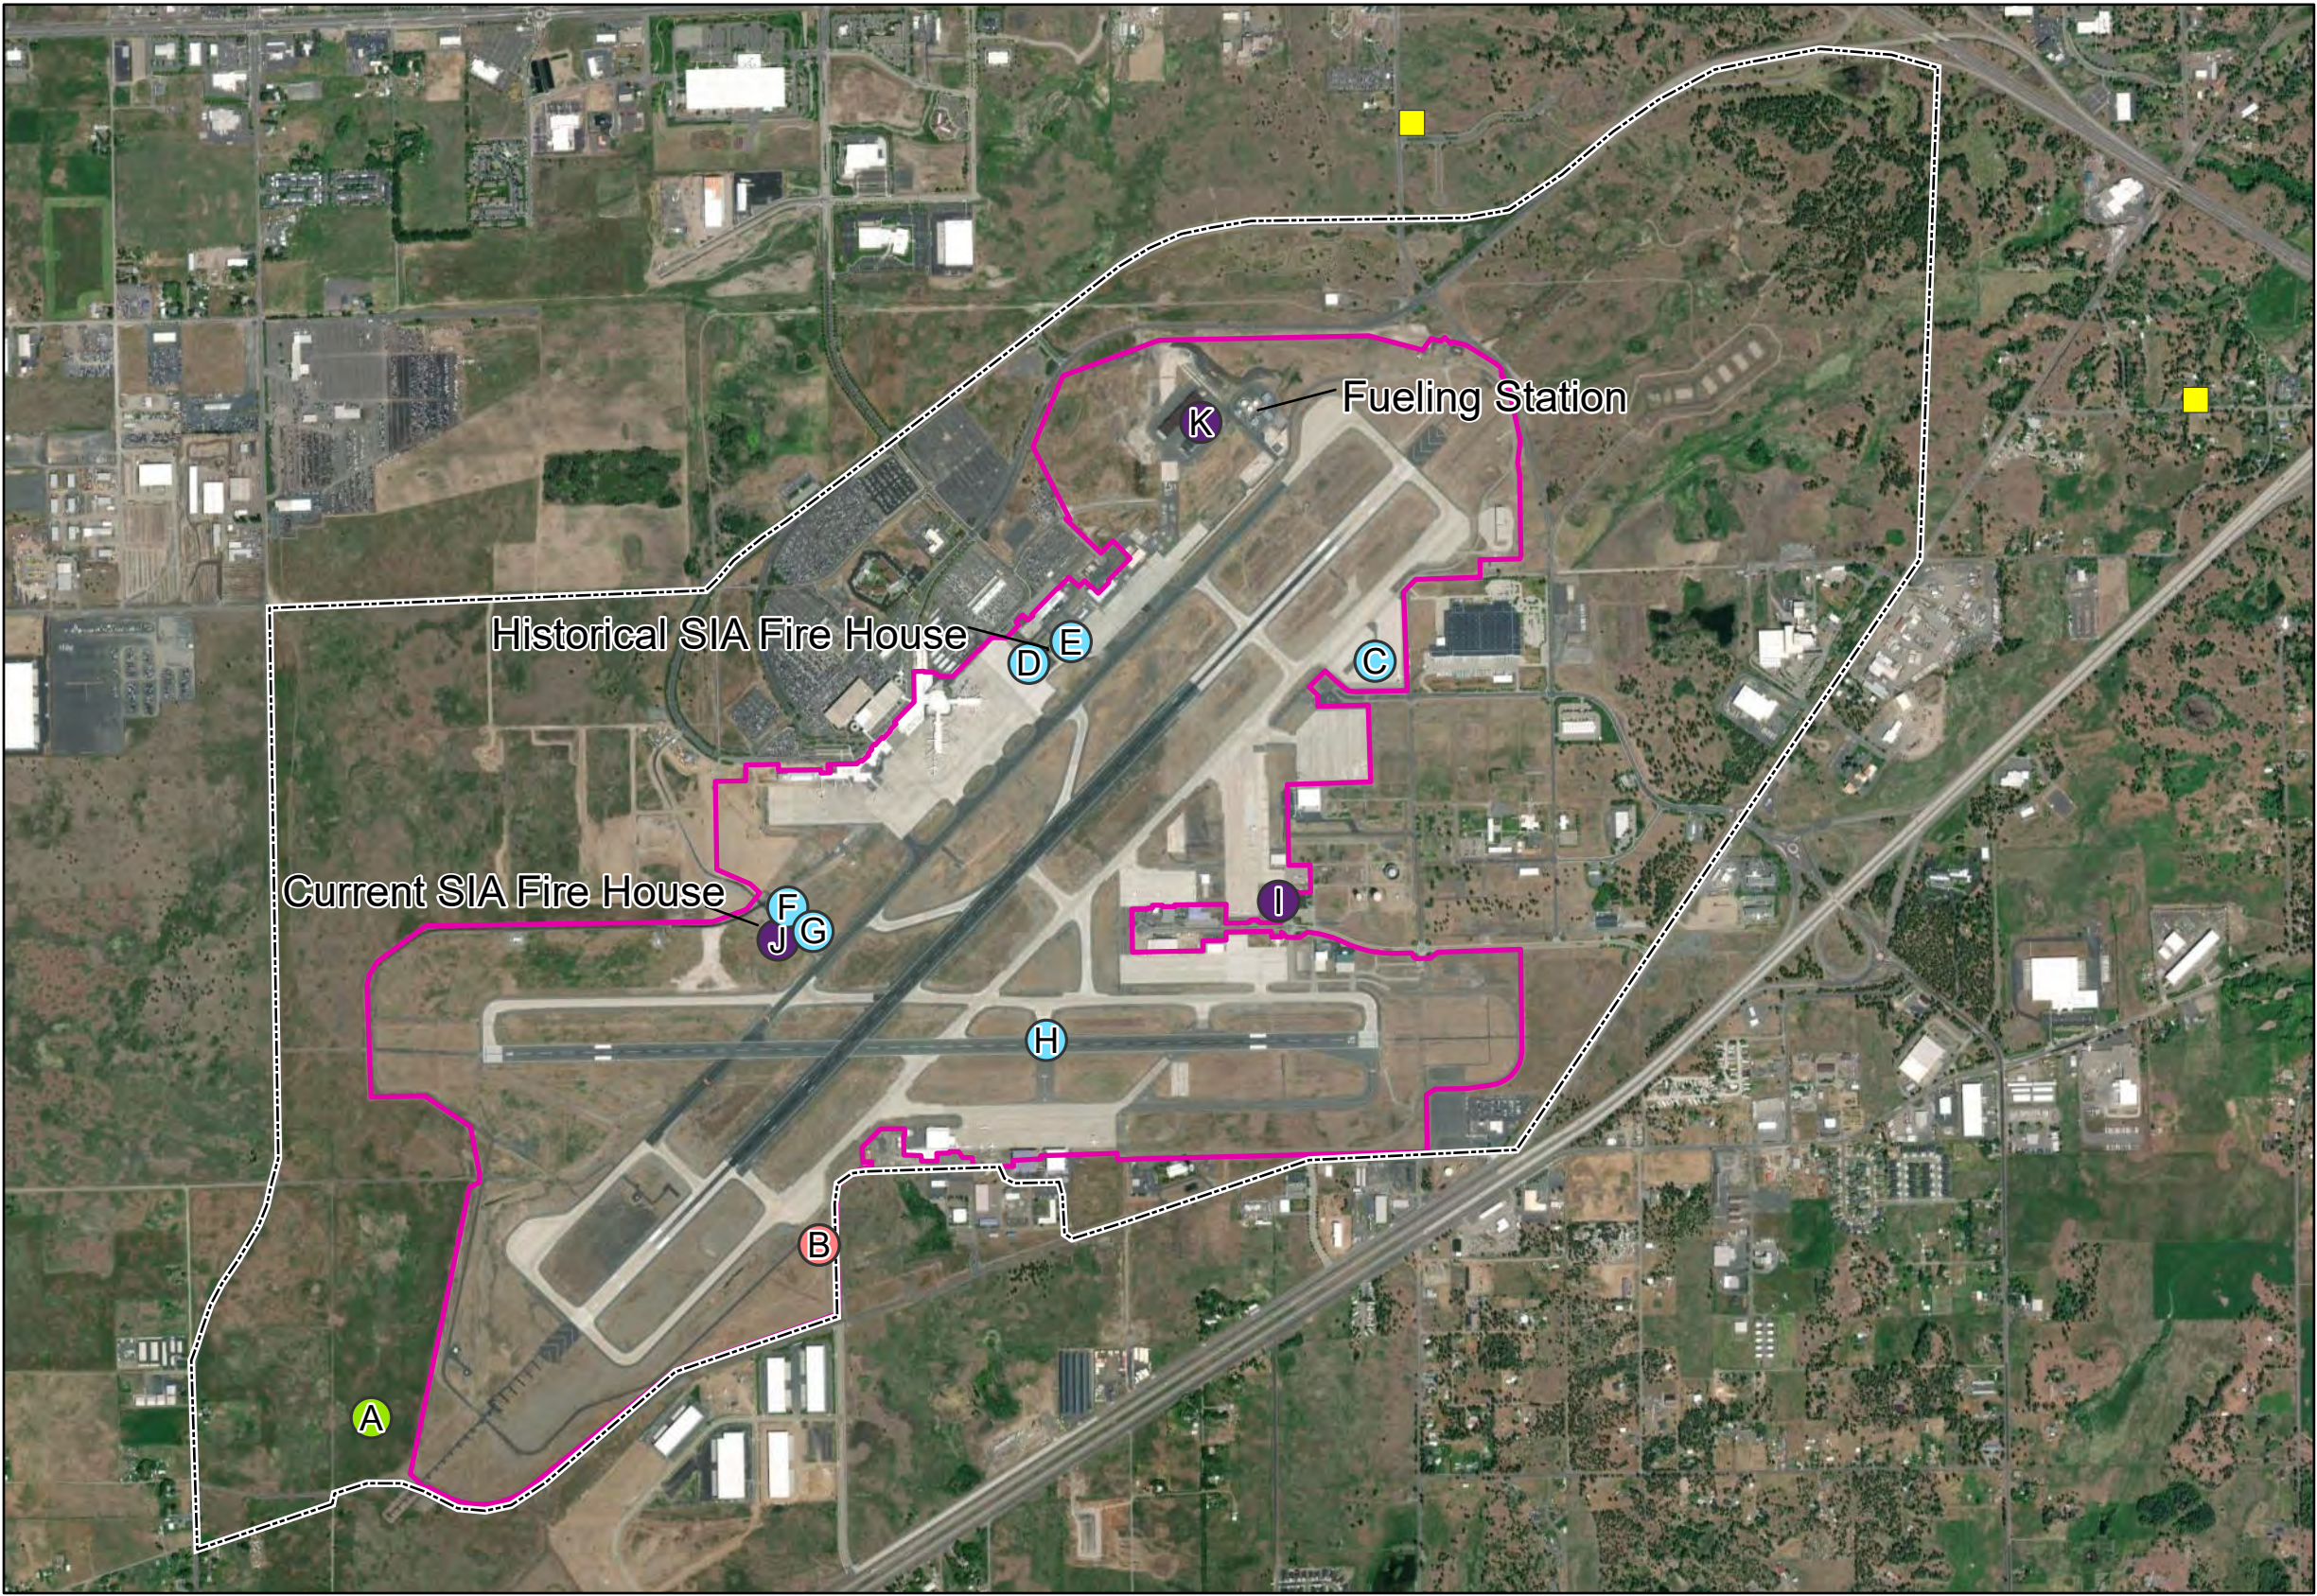
GSI Job No.	6892	Drawn By:	EKS
Issued:	13-Aug-2024	Chk'd By:	KW
Map ID:	SIAWA_AFFF	Appv'd By:	KW
FIGURE 4.1

- 1.) AOA - Air Operations Area
- 2.) AFFF - Aqueous Film-Forming Foam
- 3.) ANG - Air National Guard
- 4.) The Joint Training Area (location B) was utilized through 1999.
- 5.) The Triangle Ramp Training Area (location C) has been utilized since 2000.
- 6.) Aerial imagery provided by Esri ArcGIS Online, 2023.

A	Potential: Aviation Incident - 1994
B	Known: ANG-SIA Joint Training Area
C	Potential: Triangle Ramp Training Area
D	Known: Historical SIA Fire House
E	Potential: Historical SIA Fire House
F	Known: North of Current SIA Fire House
G	Known: SE of Current SIA Fire House
H	Known: Taxiway K Testing Area
I	Hangar 725
J	Current SIA Fire House
K	Field Maintenance Building
