SITE ASSESSMENT REPORT

Spokane International Airport

AECOM, 2017b. Monitoring Well Installation and Groundwater Monitoring for Perfluorinated Chemicals.

Re: Monitoring Well Installation and Groundwater Monitoring for Perfluorinated Chemicals Spokane International Airport Spokane, Washington SIA Contract #17-43-9999-020-001-00 <u>AECOM Job No.:60557313</u>

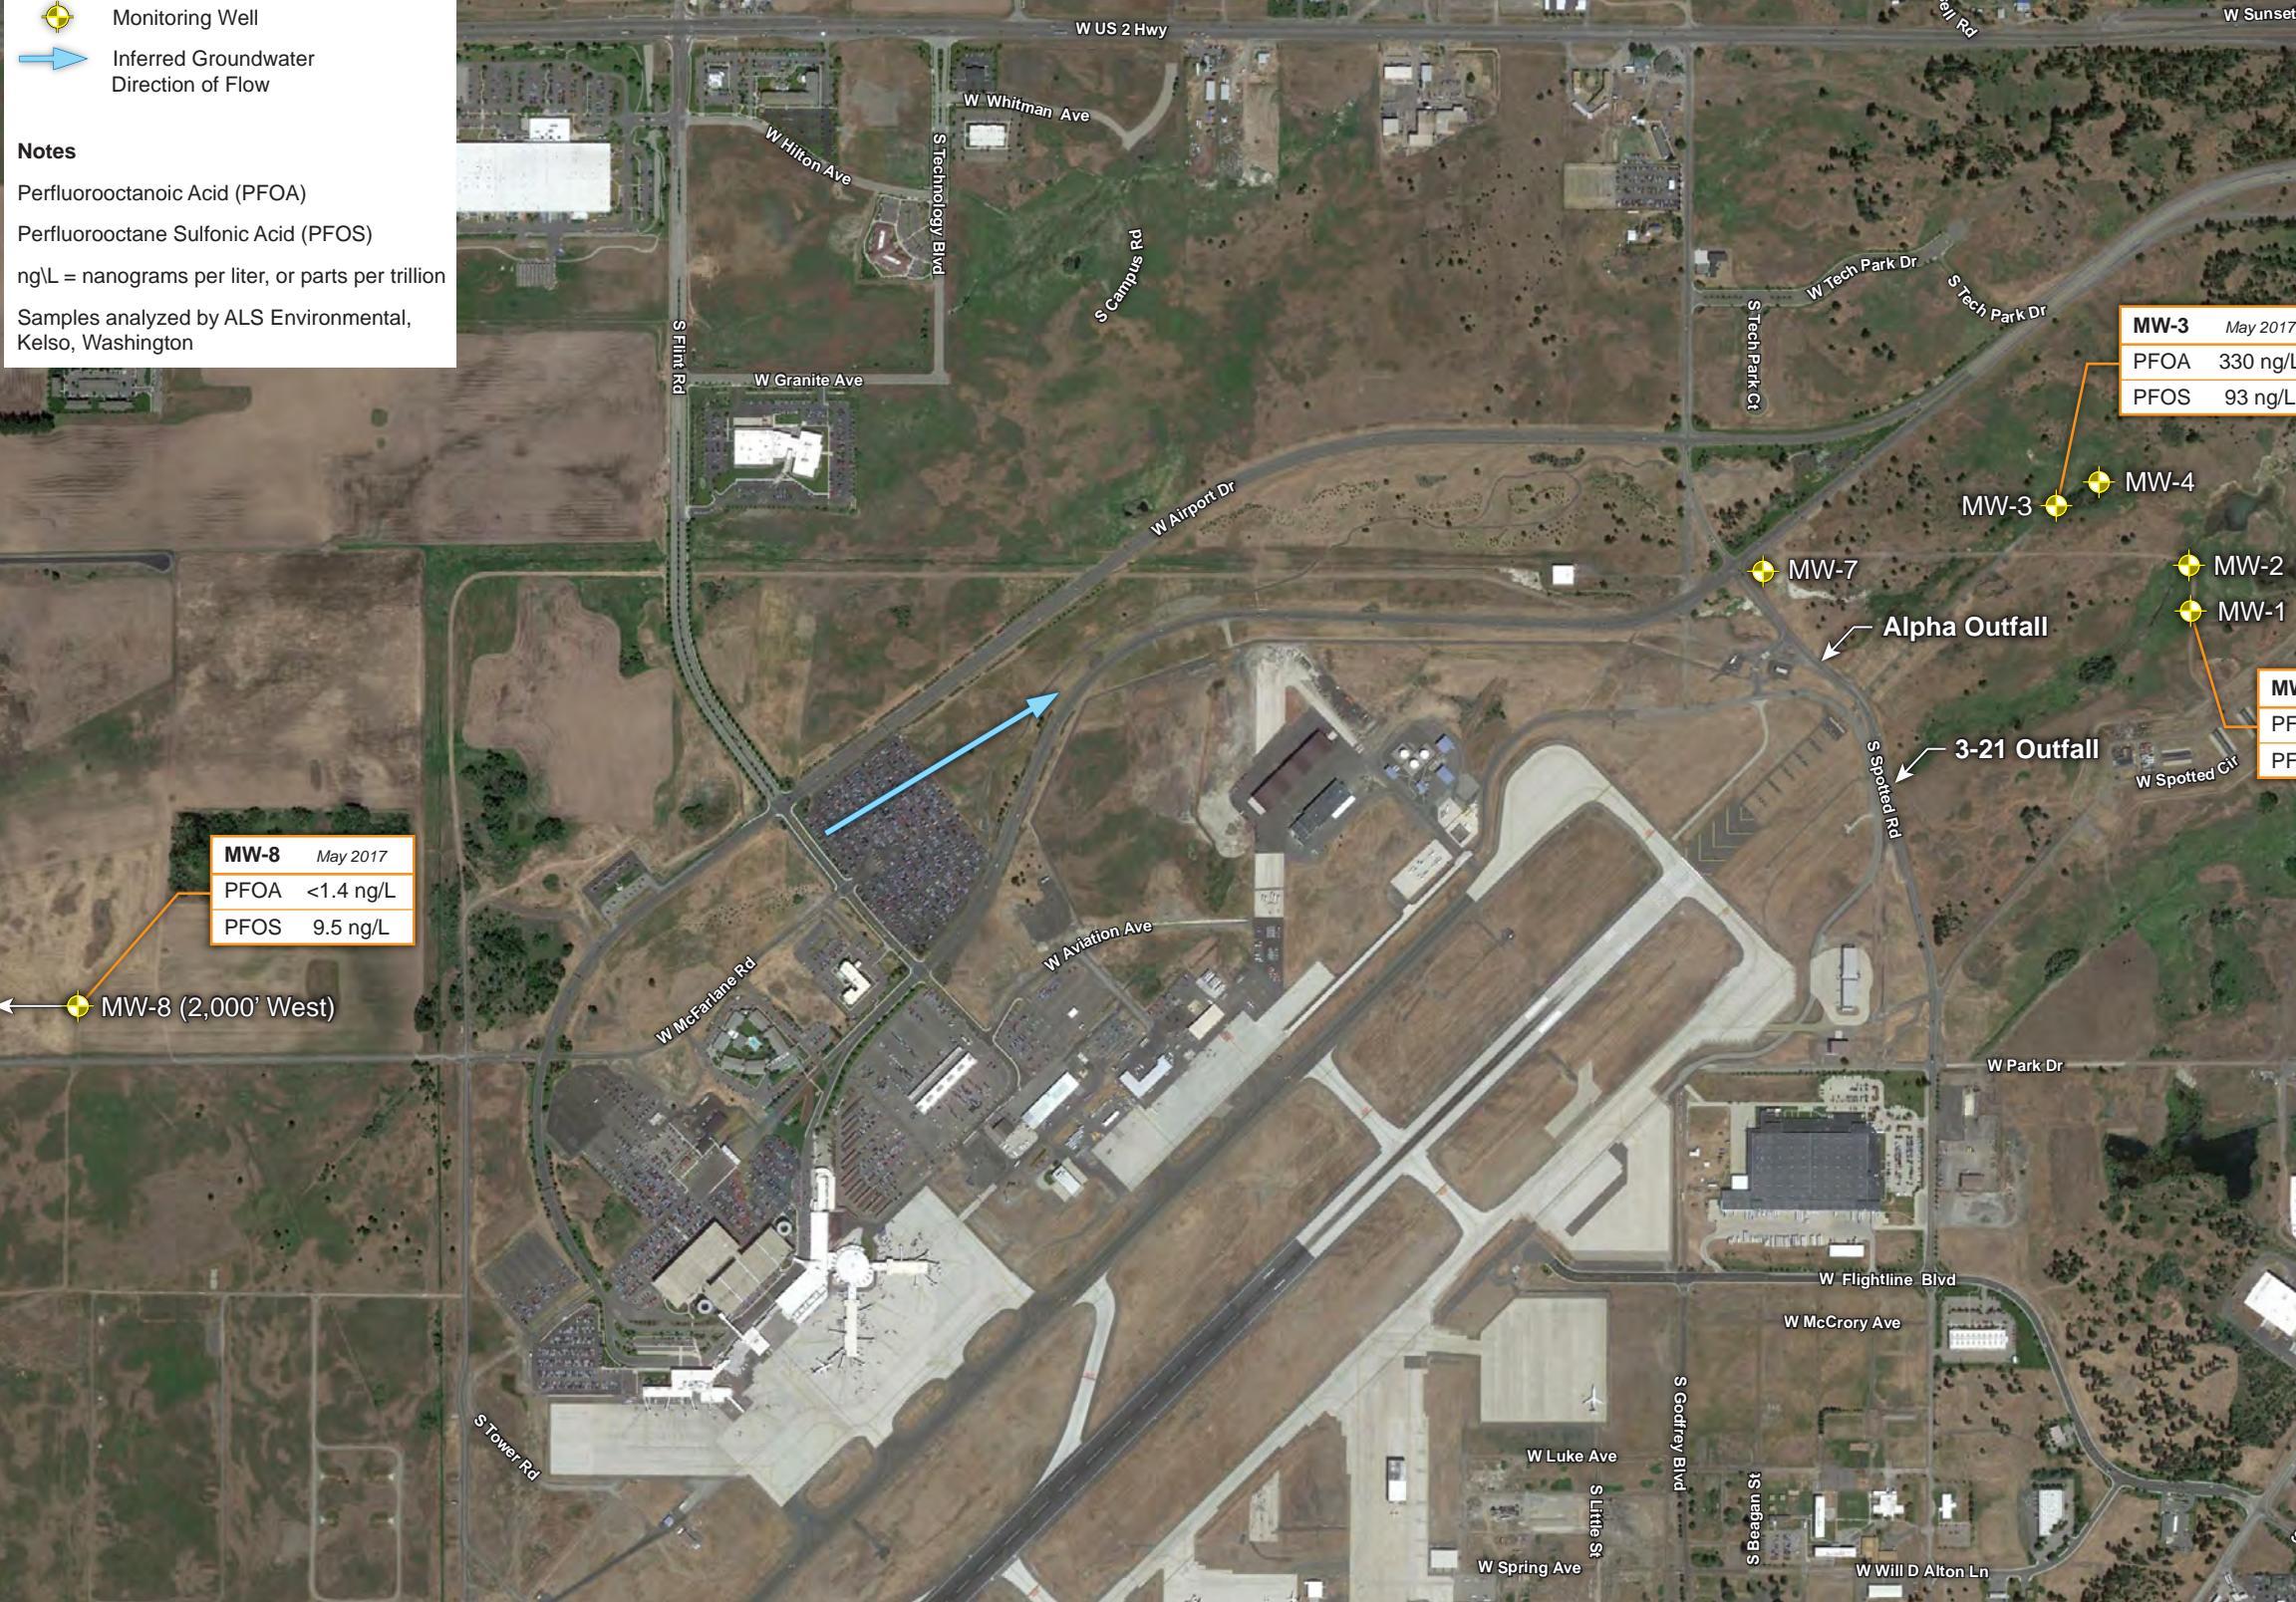
Figure 1 Spokane International Airport **PFOA/PFOS Study Area**

Groundwater levels measured in the monitoring wells on November 8, 2017 were noted at depths ranging from 6.90 to 10.00 feet bgs. Groundwater samples were collected from monitoring wells MW-5, MW-13 and MW-14. Monitoring well locations, depth to water and analytical results are shown on **Figure 1**.

Rd.	E.A.	R. S.				
et Front	w Sunset	Hwy W 2 Hwy	Land the				and the
				AN AN			and a state
- 80			11		MW-1	4 Nov. 201	7
1	a se sant		1		PFO	S 50 ng/L	
7 ′L			4	MW-14

-	🔶 MW-	.6			MW PFC	/-13 Nov. 2 DA 85 ng	017 g/L
	i de la cale				PF	OS 72 ng	g/L
1	52. A	🔶 MW-5		🔶 MW-1	3		
W-1	May 2017			-			3
	120 pg/l		MW-5	May 2017	Nov. 2017	200	
FOR	120 ng/L		PFOA	110 ng/L	66 ng/L	3	
-03	130 Hg/L	144	PFOS	140 ng/L	120 ng/l	-	
	322	the spat	14 A.		a star	1 1 1 1 1 1 1 1 1 1 1 1 1 1 1 1 1 1 1	charante at
5			-		195	Contraction of the	and the
	100		-	1/23	CHLI & GRAT
