SITE ASSESSMENT REPORT

Spokane International Airport

SES, 2019b. Limited Assessment of Electric Avenue Waste Disposal/Fire Pit Training Area.

RE: Limited Assessment of Electric Avenue Waste Disposal/Fire Pit Training Area Spokane International Airport Spokane, Washington SIA Contract #19-43-9999-006 <u>SES Project No.: 0270-003</u>

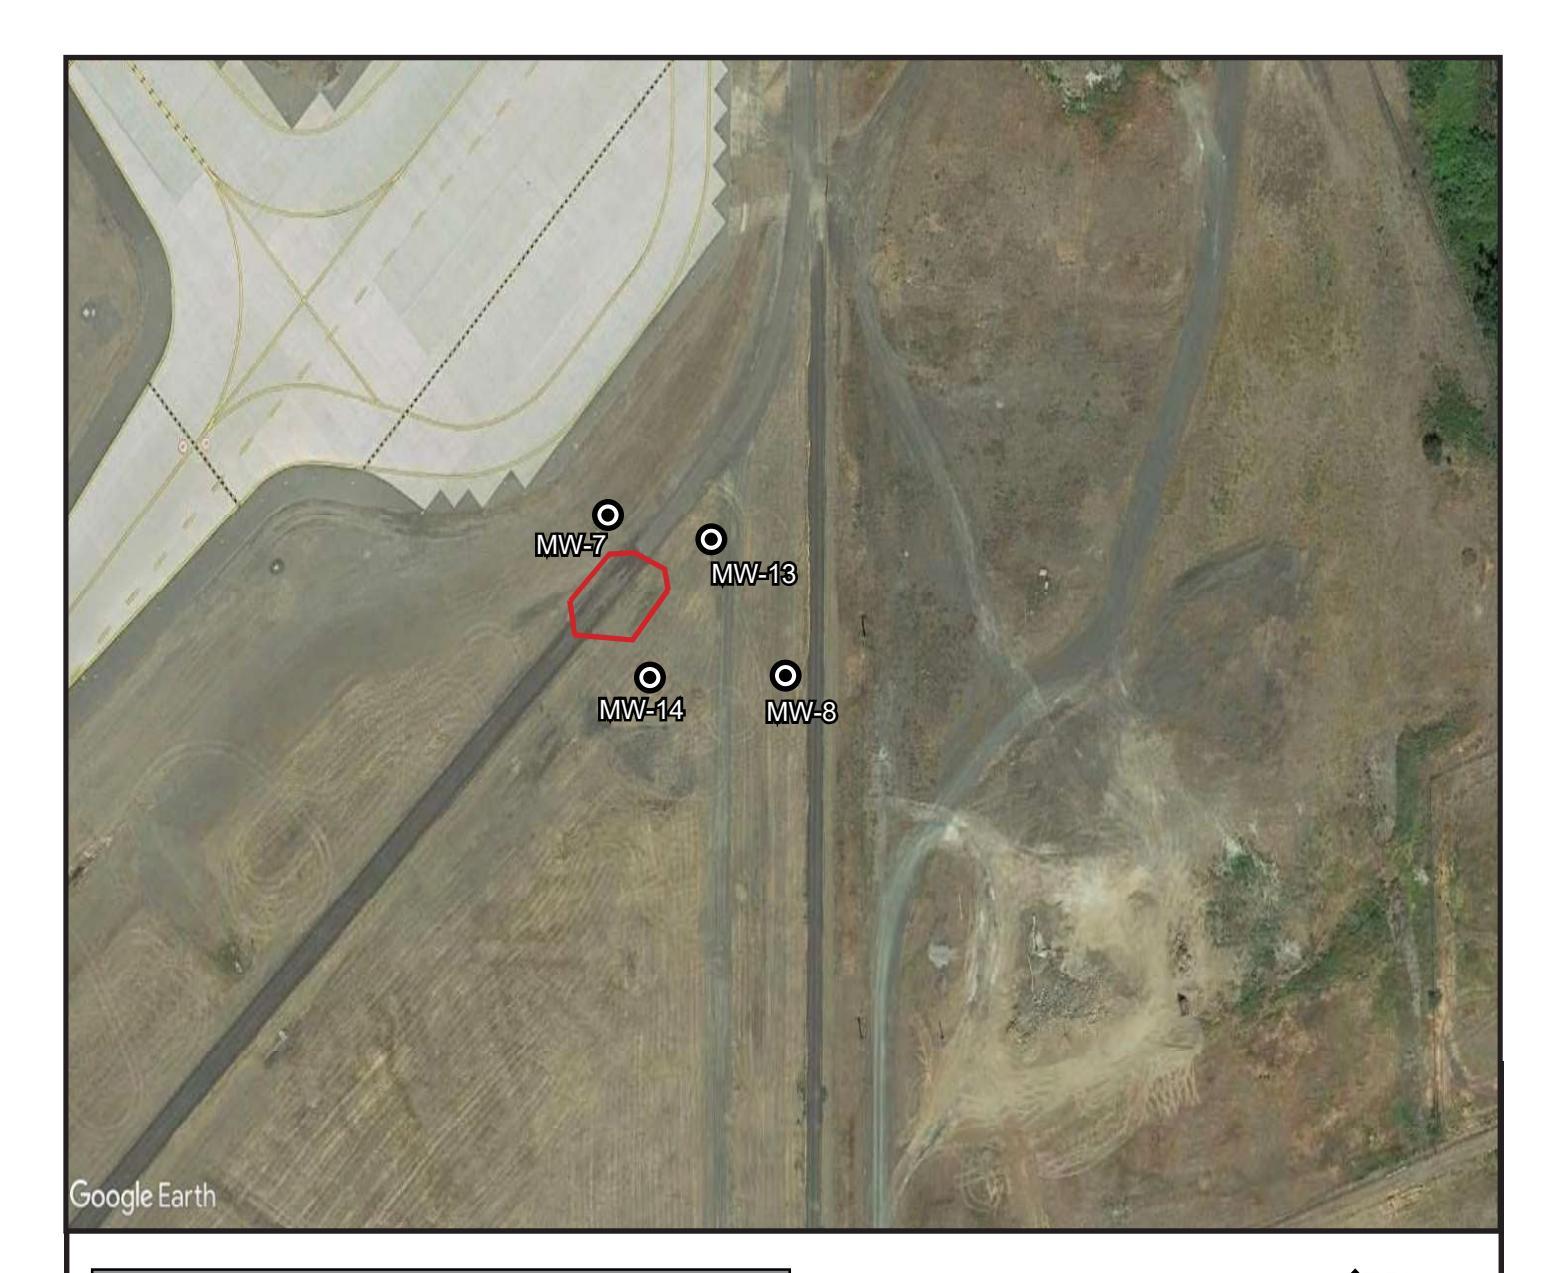
There are four pairs of monitoring wells located on site. Each pair consists of a shallow- and a deep-screened well. Monitoring well pairs MW-7 and MW-8 were installed by the Army Corps of Engineers in 1990. Monitoring well pairs MW-13 and MW-14 were installed by SIA in 1992. In each of the well pairs, the well designated by an A suffix is the deeper of the pair and is generally screened across the contact between sequenced flood sediments and the underlying basalt. Specific construction details of those wells sampled during this event are further discussed below. Monitoring well locations are shown on **Figure 2**. Monitoring Well Logs are shown in **Attachment A**.

Site Monitoring Wells Pairs

Burn Pit - location based on observation from historic aerial photographs.

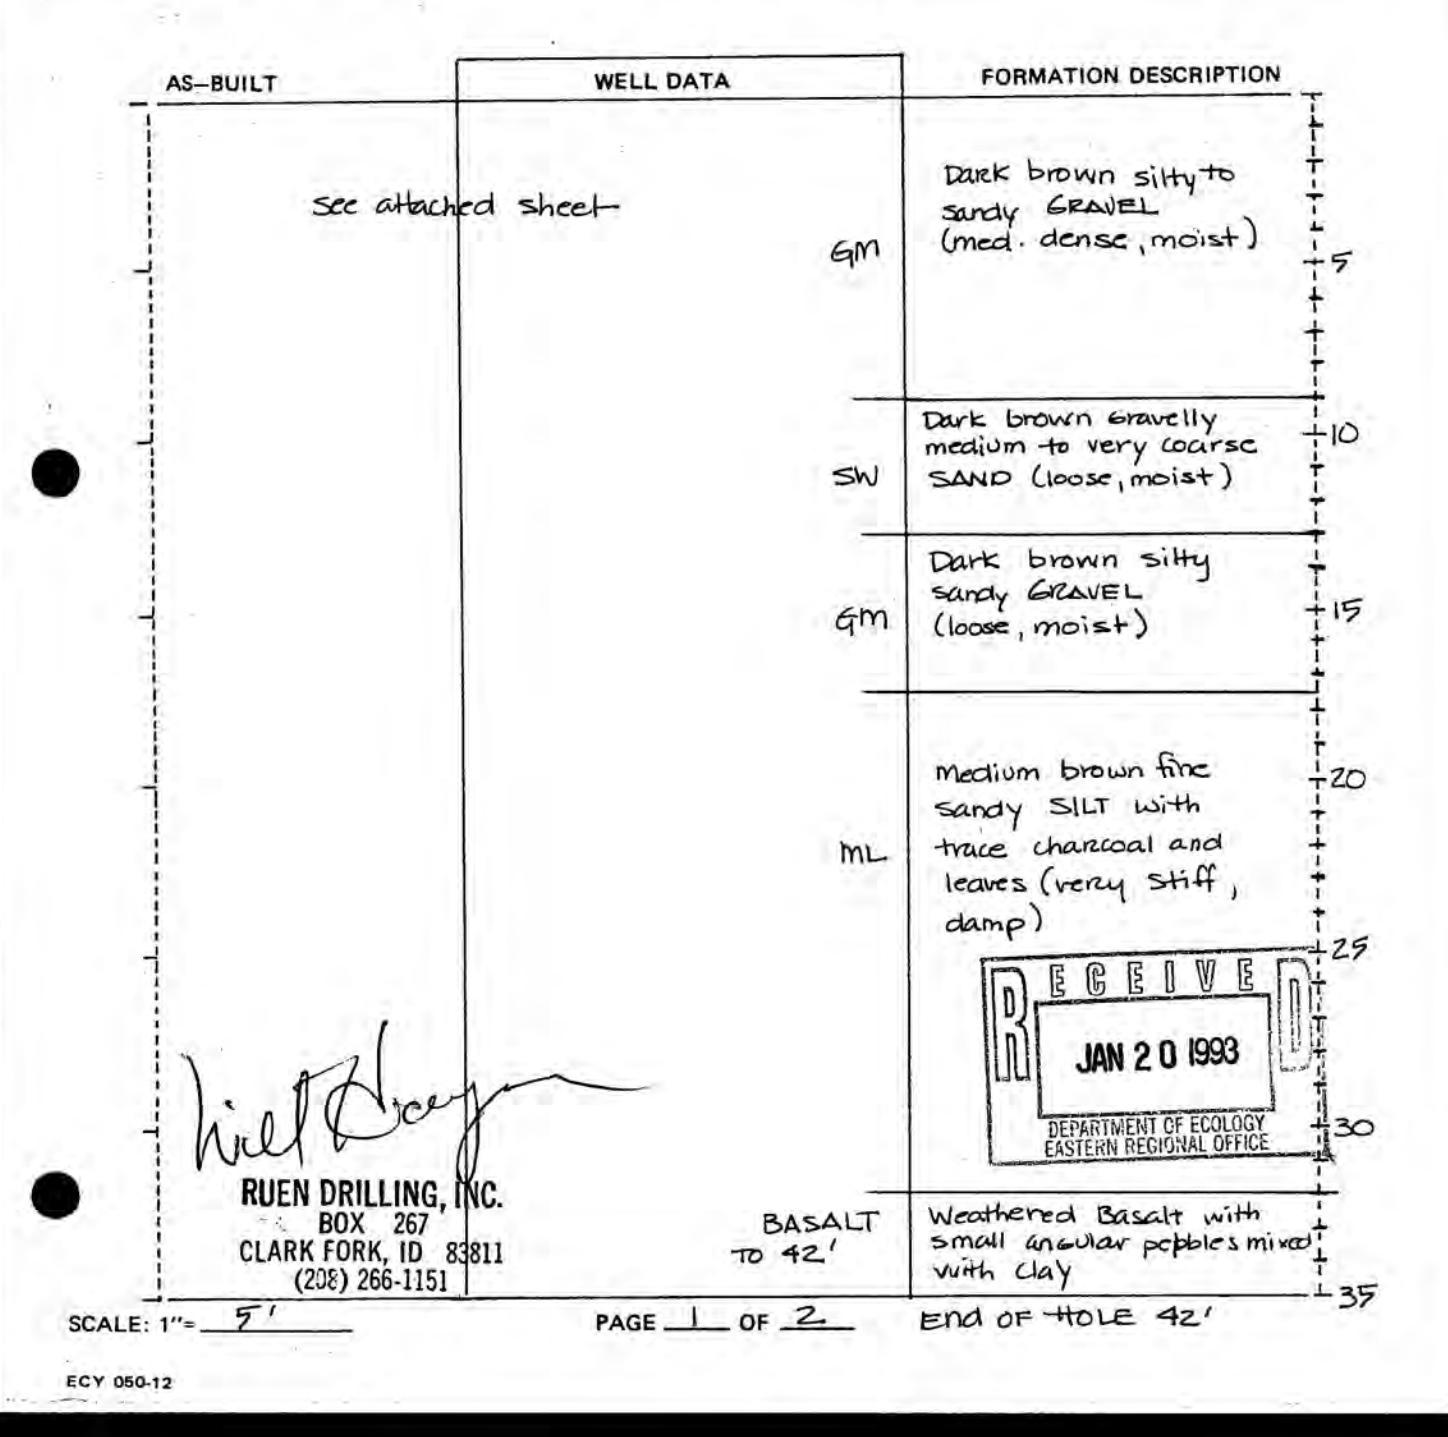
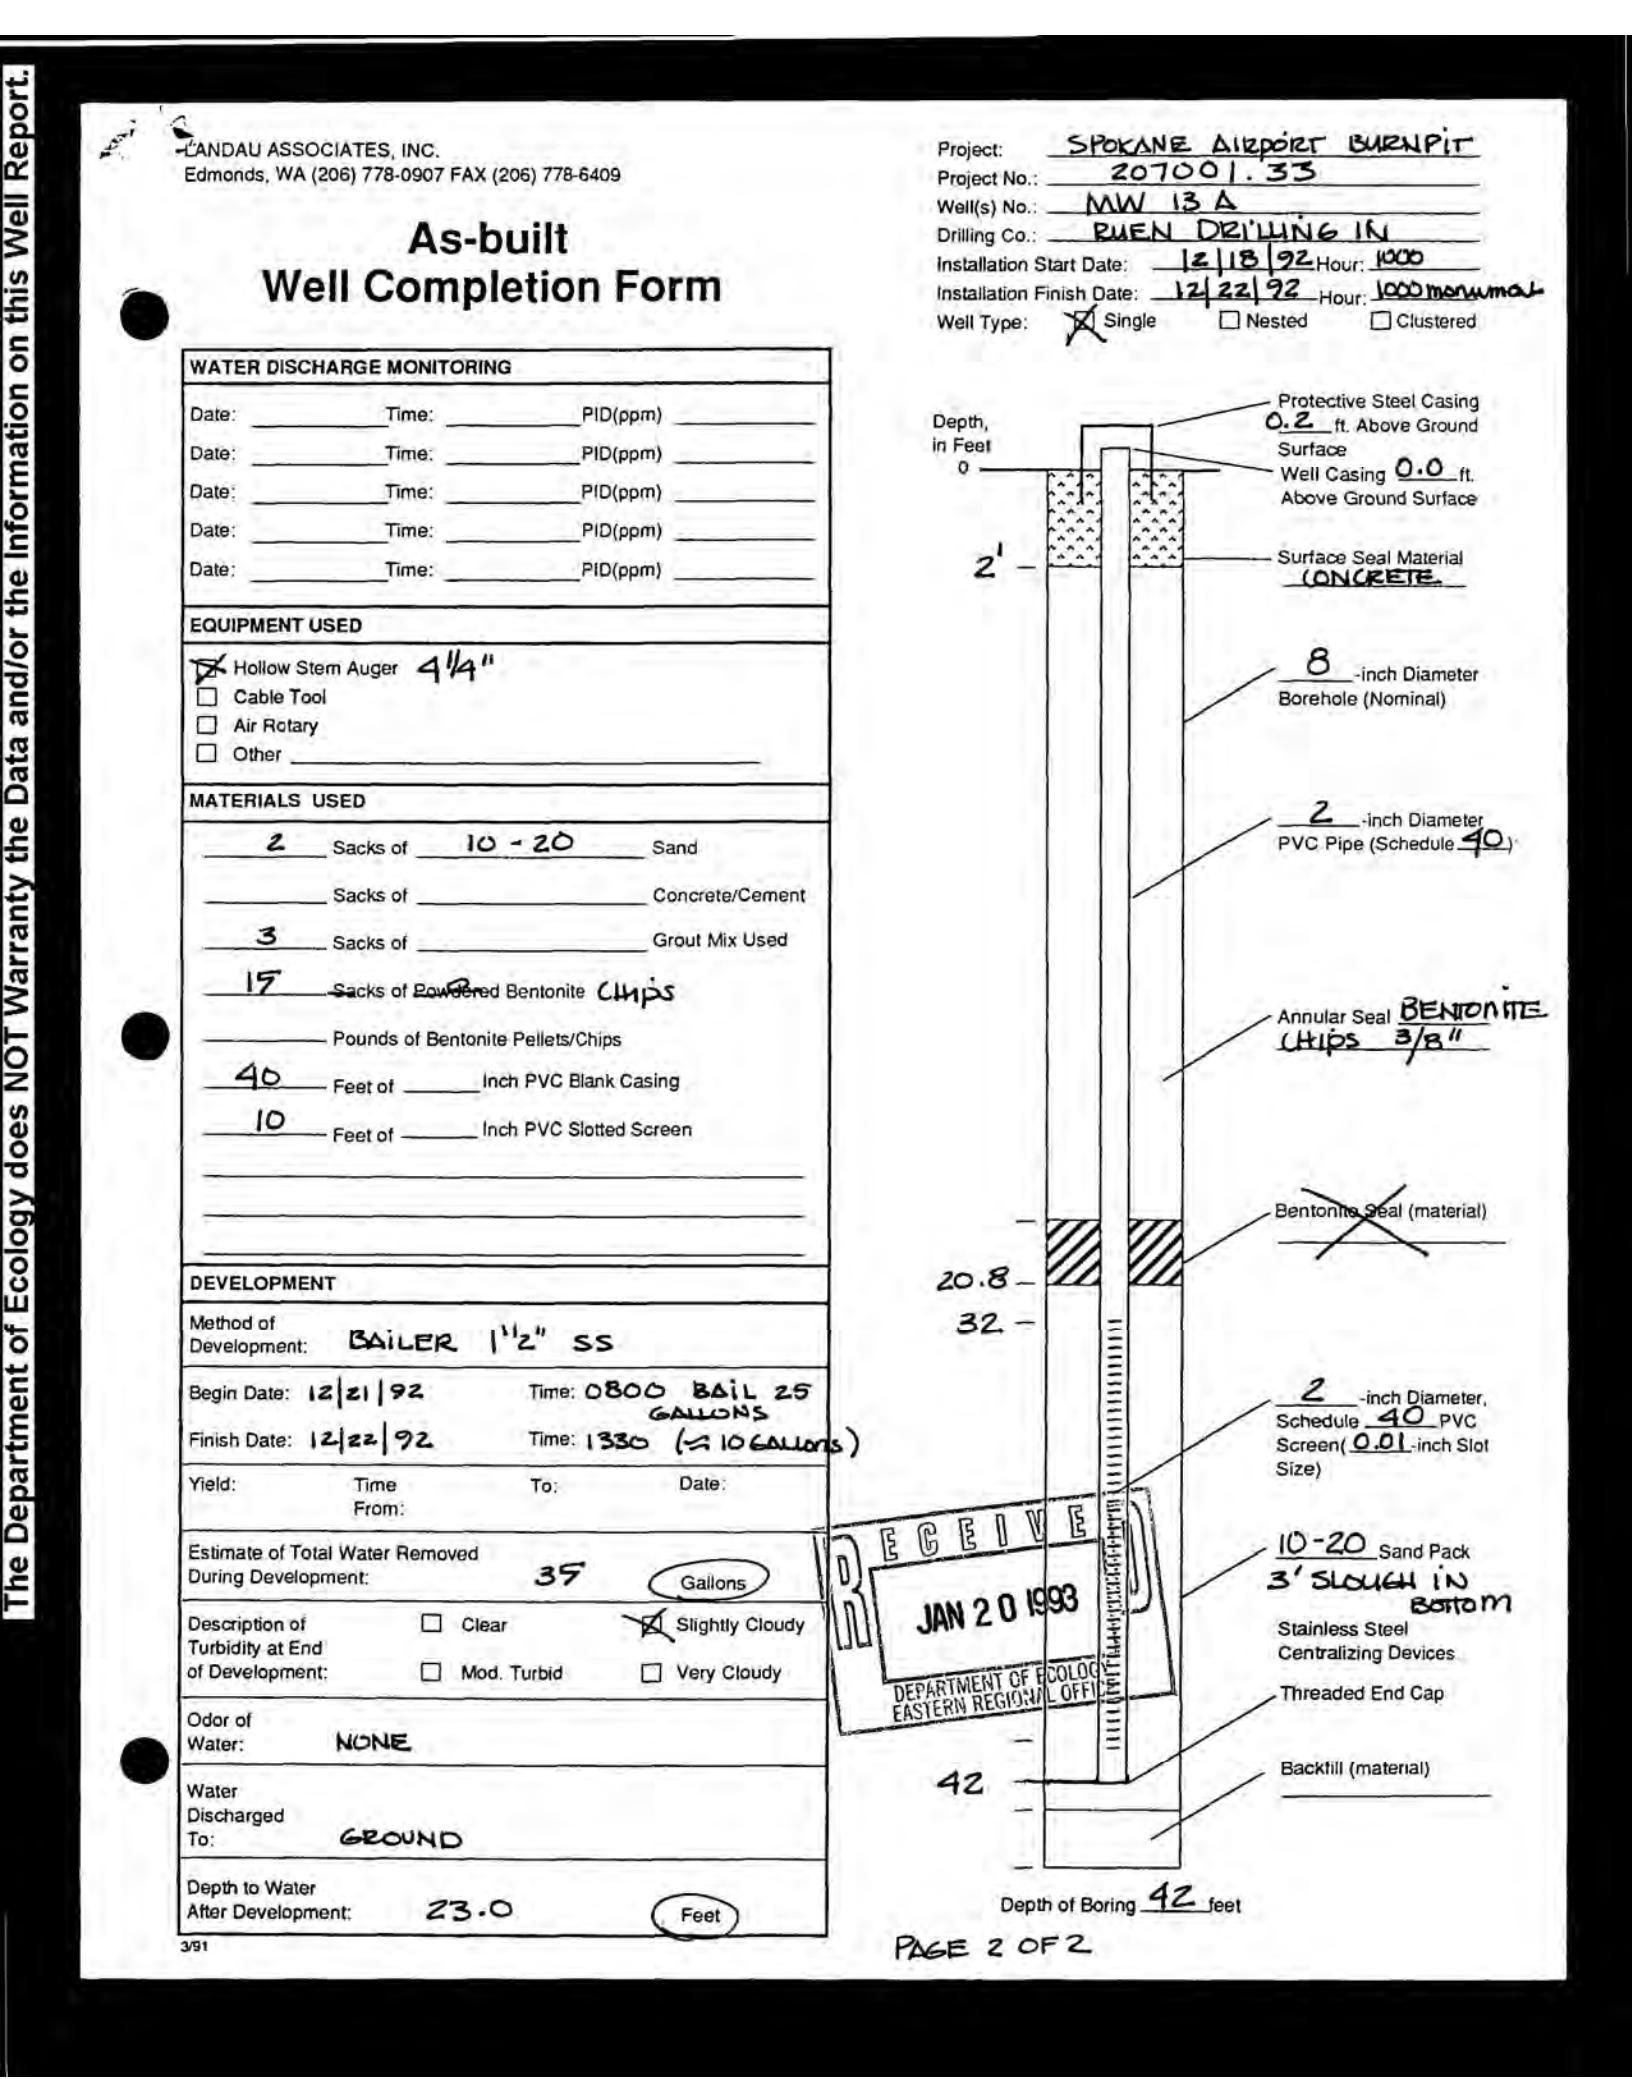
RESOURCE PROTECTION WELL REPORT

PROJECT NAME: SPOKANE AIRPORT BURN PIT	LOCATION: TZAN, RAZE, SEC. 6 1/4 NE 1/4 NE
RILLING METHOD: 414" HOLLOW STEM AUGER \$ AL	ARY DISTANCE (W) 112_ FT. FROM N/S SECTION LINE
DRILLER: WILL HAYES (2035) FIRM: EVEN DRILLING, INC (RUENCOT)	159 BATUM: USES MONUMENT 250' SOUTH OF RUNWAY
SIGNATURE:	WATER LEVEL ELEVATION: (23') 2,357.1'
REPRESENTATIVE: DEB SULLEL	DEVELOPED: 12/22/92
